**Flood Control Project Maintenance
Levee Inspections**

Maintenance Issue Types Only, Levee Inspection Report By Mile - Spring 2015

Reclamation District No. 1602 Del Puerto

Waterway	Bank	Unit Miles	Inspection Start/End	Inspector
Unit No. 01 San Joaquin River	Left	6.24	04/02/2015 04/02/2015	Pavel Kazi

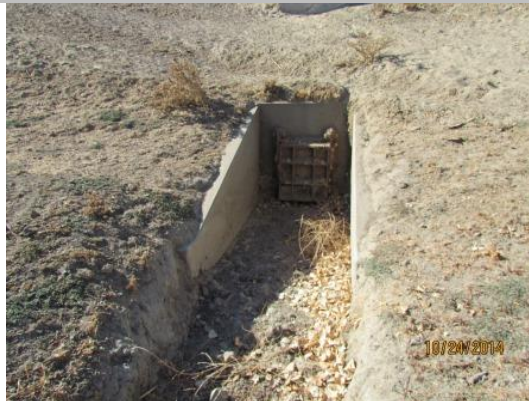
Photo 1 of 4 : SP_2015_RD1602_110_72_20150313_00042.jpg

LM Start	0.77	Rating **	A/W	Issue No.	72
LM End	0.77	Issue Type +	Ma	Location *	WS
Category	Interior Drainage & Piping Systems			GPS Latitude/Longitude	
				Start	End
Item	Flap Gates			37.477965 °	37.477965 °
				-121.072595 °	-121.072595 °
DWR ID	DWR_RD1602_01_s_2012_72				
Action/Comments					
Inspector Comments: Sediment around the flap gate was cleaned, and the area should be watched for future sediment deposits.

View of the flap gate on the waterside of the levee during fall 2014 inspection.

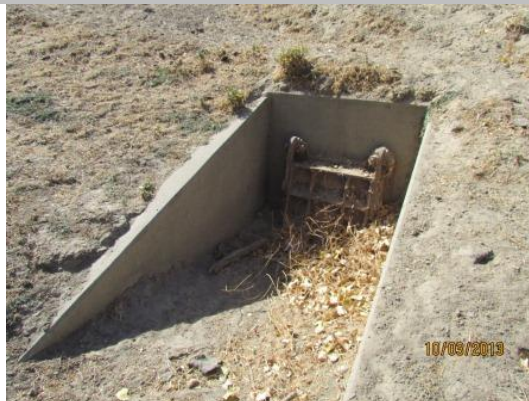
Photo 2 of 4 : SP_2015_RD1602_110_72_20150313_00043.jpg

Debris were obstructing the flap gate from closing completely. The picture was taken from toe of waterside of the levee during the fall 2013 inspection.

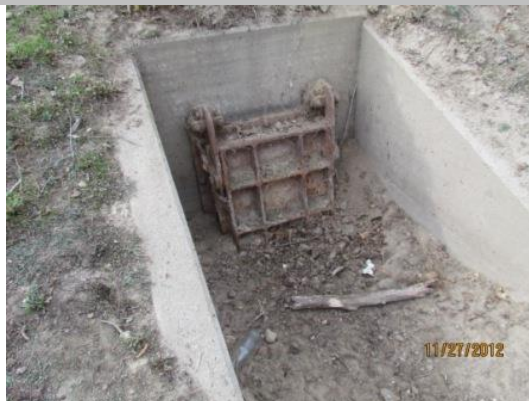
Photo 3 of 4 : SP_2015_RD1602_110_72_20150313_00044.jpg

Debris and sediments were obstructing the flap gate from closing completely. The picture was taken from toe of waterside of the levee during the fall 2012 inspection.

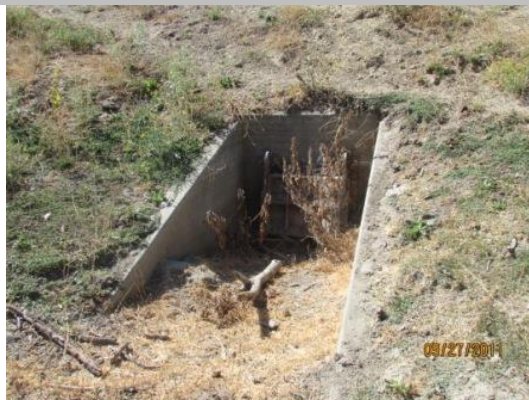
Photo 4 of 4 : SP_2015_RD1602_110_72_20150313_00045.jpg

Debris and sediments were obstructing the flap gate. The picture was taken from toe of waterside of the levee looking towards the crown. This picture was taken during the fall 2011 inspection.

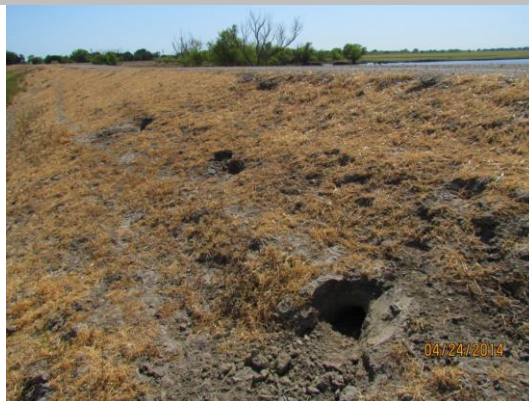
Photo 1 of 3 : SP_2015_RD1602_110_76_20150313_00048.jpg

Updated picture of the rodent holes on the waterside of the levee looking upstream during spring 2014 inspection.

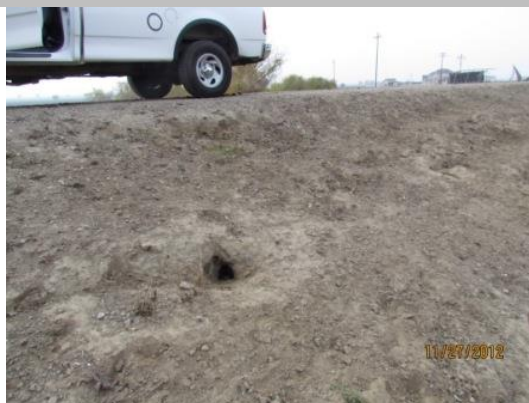
Photo 2 of 3 : SP_2015_RD1602_110_76_20150313_00049.jpg

Updated picture of the rodent hole on the waterside slope of the levee looking downstream.

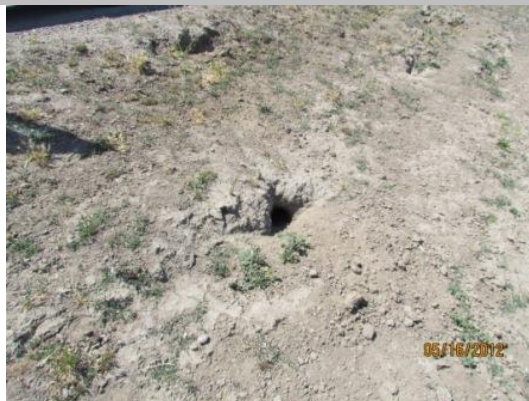
Photo 3 of 3 : SP_2015_RD1602_110_76_20150313_00050.jpg

A rodent hole was found on the waterside of the levee looking downstream.

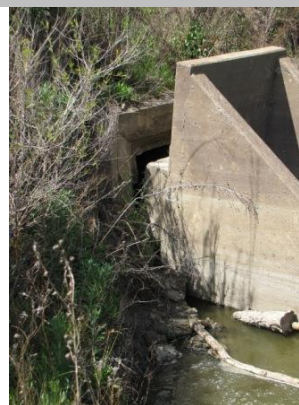
Photo 2 of 3 : SP_2015_RD1602_110_55_20150313_00029.jpg

Separation of outfall structure from the outlet pipe at LM 1.04.

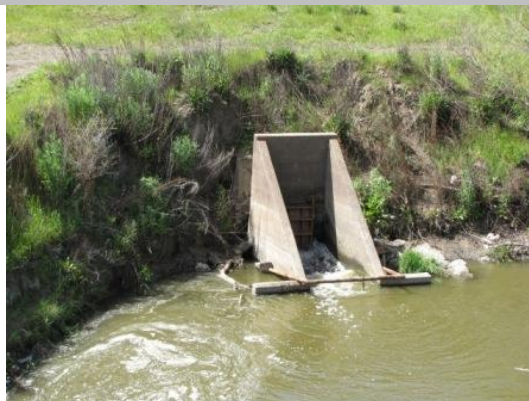
Photo 3 of 3 : SP_2015_RD1602_110_55_20150313_00028.jpg

Additional view of outfall structure at LM 1.04.

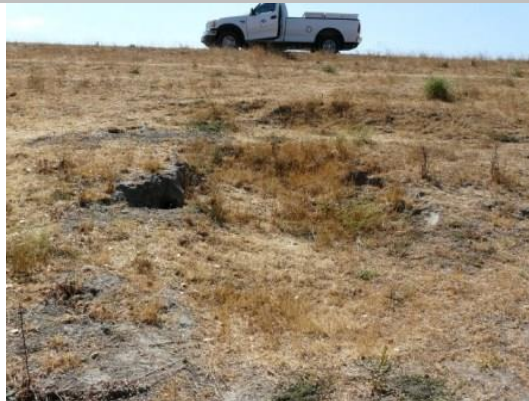
Photo 1 of 3 : SP_2015_RD1602_110_37_20150313_00015.jpg

LM Start	1.05	Rating **	M	Issue No.	37
LM End	1.05	Issue Type +	Ma	Location *	WS
Category	Earthen Levee			GPS Latitude/Longitude	
				Start	End
Item	Slope Stability			37.478567 °	37.478567 °
				-121.067847 °	-121.067847 °
DWR ID	DWR_RD1602_01_s_2012_37				
Action/Comments					
Repair slope instability. Inspector Comments: Small amount of slumping at waterside toe of the levee.

Small amount of slumping at water toe.

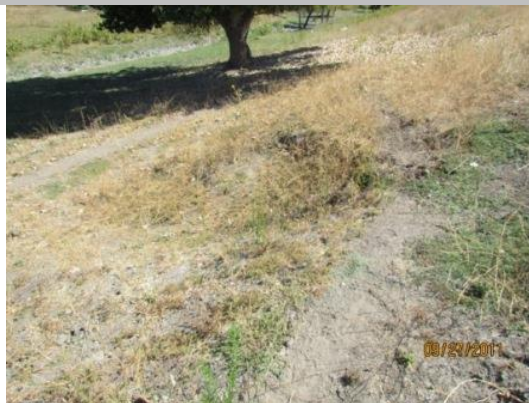
Photo 2 of 3 : SP_2015_RD1602_110_37_20150313_00016.jpg

Updated picture of the depression at the waterside toe of the levee. The picture was taken from the crown of the levee looking upstream.

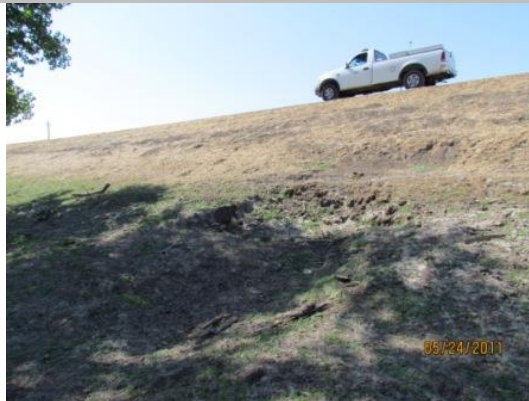
Photo 3 of 3 : SP_2015_RD1602_110_37_20150313_00017.jpg

Depression at the waterside slope of the levee during Spring 2011 inspection.

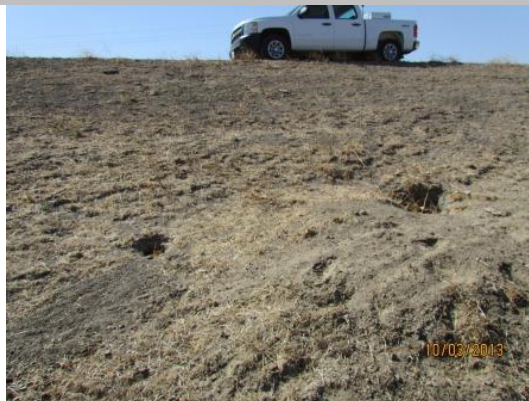
Photo 1 of 2 : SP_2015_RD1602_110_11_20150313_00002.jpg

Rodent holes were found on the waterside slope of the levee looking downstream.

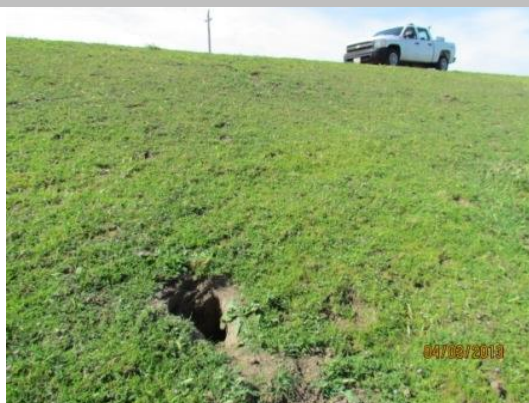
Photo 2 of 2 : SP_2015_RD1602_110_11_20150313_00003.jpg

A rodent hole was found on the waterside toe of the levee looking downstream.

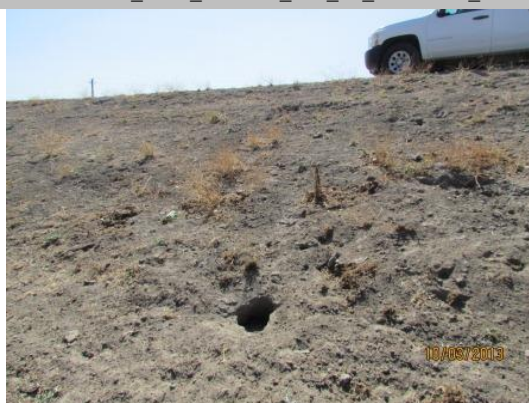
Photo 1 of 2 : SP_2015_RD1602_110_65_20150313_00037.jpg

Updated picture of rodent hole on the waterside slope of the levee looking upstream during fall 2013 inspection.

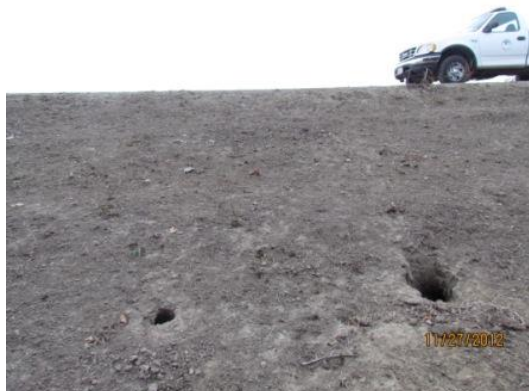
Photo 2 of 2 : SP_2015_RD1602_110_65_20150313_00038.jpg

Rodent holes were found on the waterside toe of the levee. The picture was taken from toe of the levee looking towards the crown.

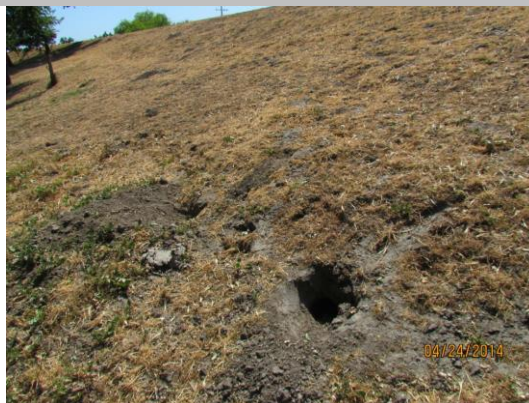
Photo 1 of 2 : SP_2015_RD1602_110_79_20150313_00051.jpg

Updated picture of the rodent holes on the waterside toe of the levee during spring 2014 inspection.

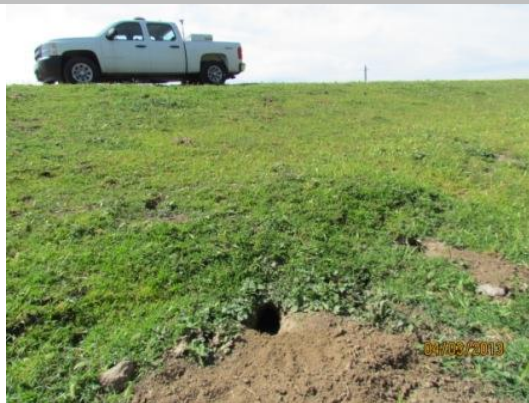
Photo 2 of 2 : SP_2015_RD1602_110_79_20150313_00052.jpg

A rodent hole was found on the waterside toe of the levee looking downstream.

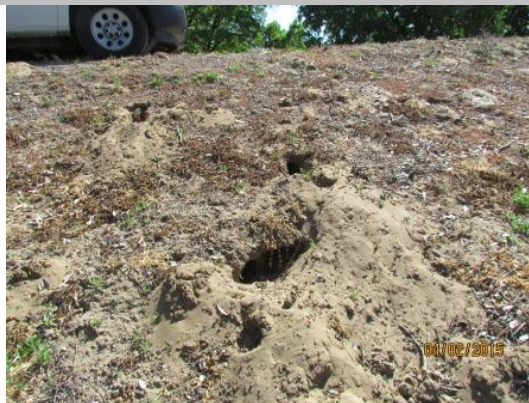
Photo 1 of 1 : SP_2015_RD1602_110_20_20150406_00080.jpg

View of rodent holes on the landside of the levee looking upstream.

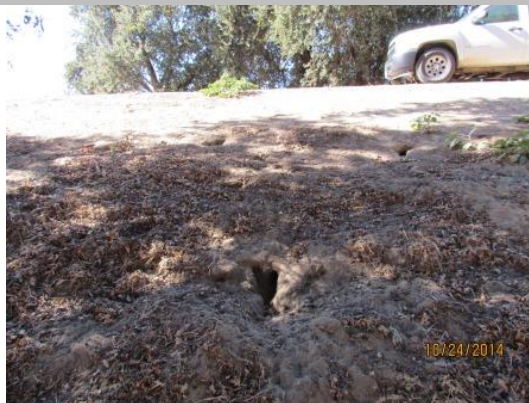
Photo 1 of 1 : SP_2015_RD1602_110_32_20150313_00012.jpg

View of the rodent holes on the waterside of the levee looking from the toe.

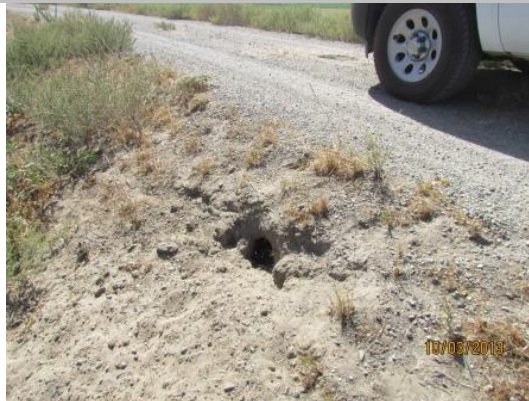
Photo 1 of 2 : SP_2015_RD1602_110_85_20150313_00053.jpg

Updated picture of a rodent hole on the waterside shoulder of the levee looking upstream during fall 2013 inspection.

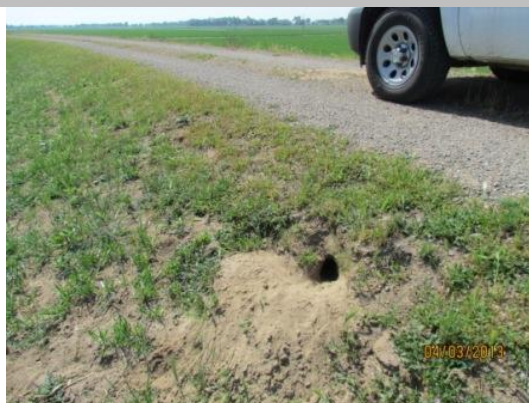
Photo 2 of 2 : SP_2015_RD1602_110_85_20150313_00054.jpg

A rodent hole was found on the waterside shoulder of the levee looking upstream.

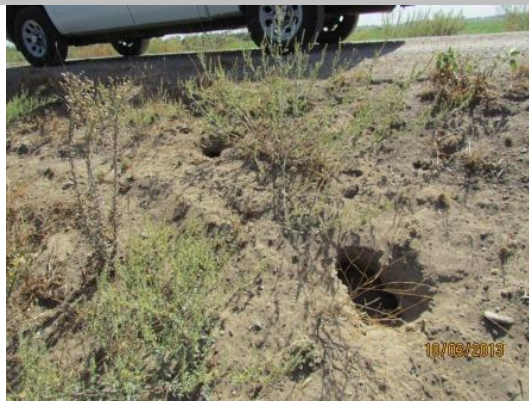
Photo 1 of 1 : SP_2015_RD1602_110_35_20150313_00013.jpg

Animal holes were found on the waterside shoulder of the levee looking upstream.

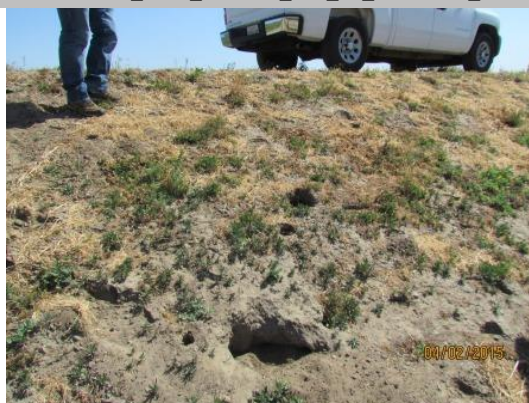
Photo 1 of 1 : SP_2015_RD1602_110_23_20150406_00081.jpg

View of rodent holes on the landside slope of the levee looking upstream.

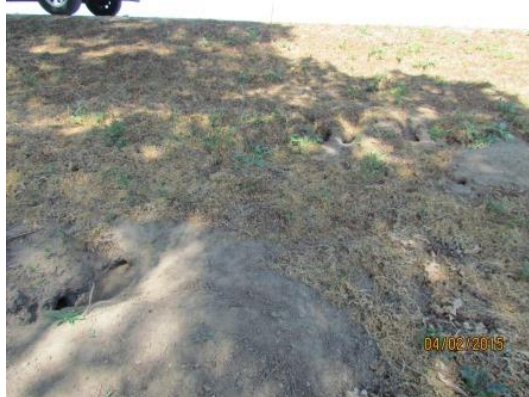
Photo 1 of 1 : SP_2015_RD1602_110_24_20150406_00082.jpg

Rodent holes were found on the waterside toe of the levee looking downstream.

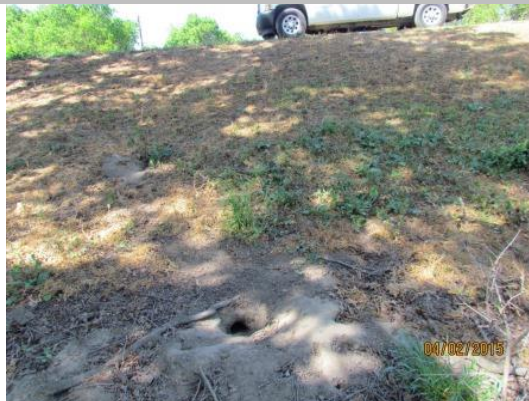
Photo 1 of 1 : SP_2015_RD1602_110_25_20150406_00083.jpg

Animal holes were found on the waterside of the levee looking upstream.

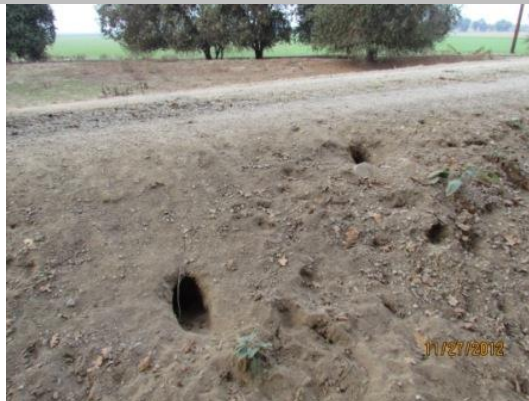
Photo 1 of 1 : SP_2015_RD1602_110_106_20150313_00059.jpg

Rodent holes were found on the waterside slope of the levee looking downstream.

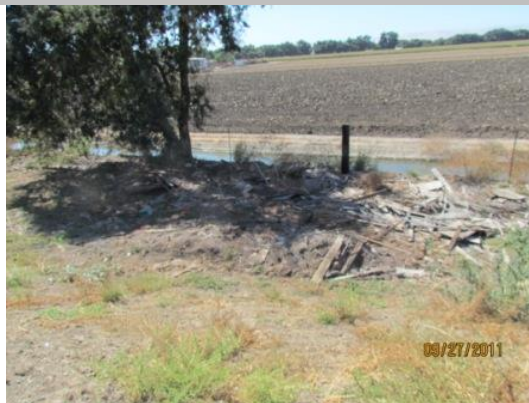
Photo 1 of 2 : SP_2015_RD1602_110_15_20150313_00004.jpg

Debris was located on the landside of the levee. The picture was taken from the crown looking upstream.

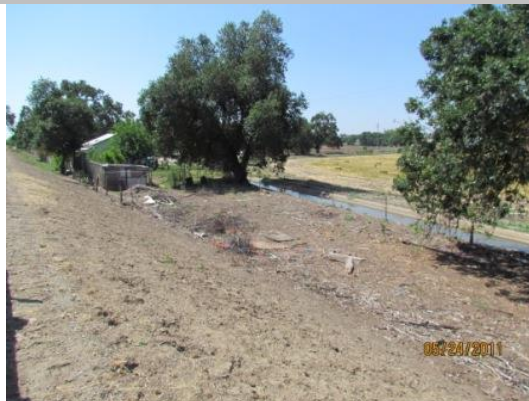
Photo 2 of 2 : SP_2015_RD1602_110_15_20150313_00005.jpg

Garbage was found on the landside of the levee. The picture was taken from the crown looking upstream.

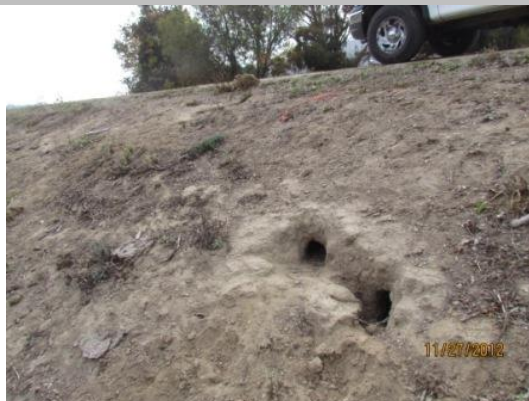
Photo 1 of 1 : SP_2015_RD1602_110_94_20150313_00056.jpg

Rodent holes were found on the waterside toe of the levee looking upstream.

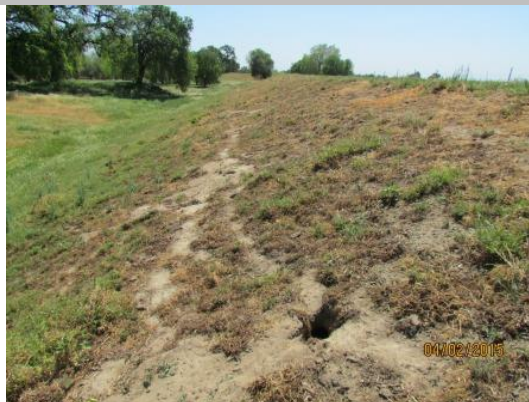
Photo 1 of 1 : SP_2015_RD1602_110_47_20150406_00084.jpg

Rodent holes were found on the waterside of the levee looking upstream.

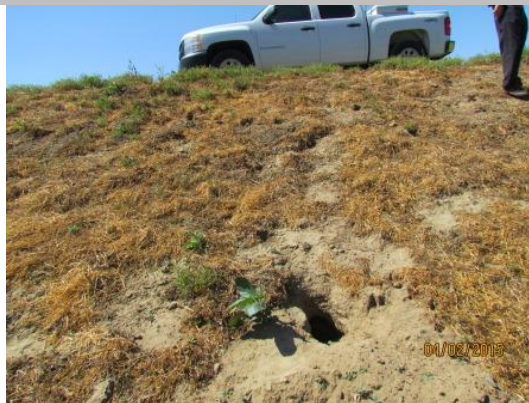
Photo 1 of 1 : SP_2015_RD1602_110_51_20150406_00085.jpg

A number of rodent holes were found on the waterside slope of the levee.

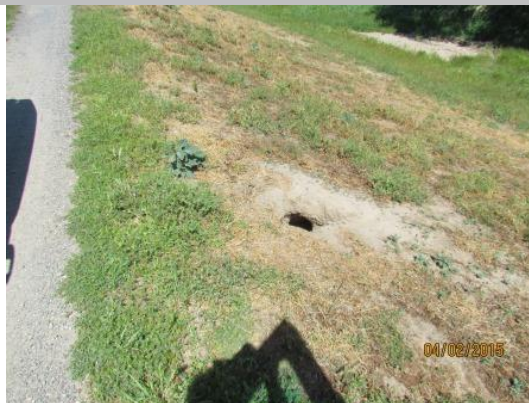
Photo 1 of 1 : SP_2015_RD1602_110_53_20150406_00086.jpg

A rodent hole was found on the waterside shoulder of the levee looking downstream.

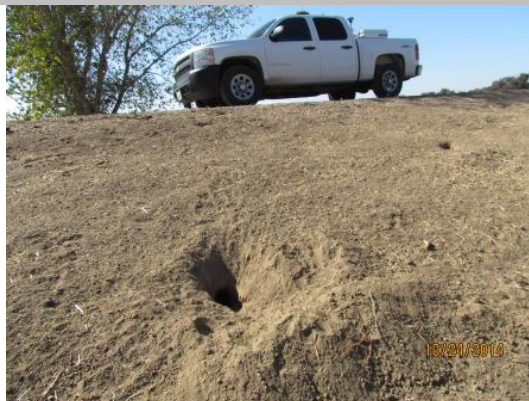
Photo 1 of 1 : SP_2015_RD1602_110_41_20150313_00018.jpg

View of a rodent hole on the waterside toe of the levee during fall 2014 inspection.

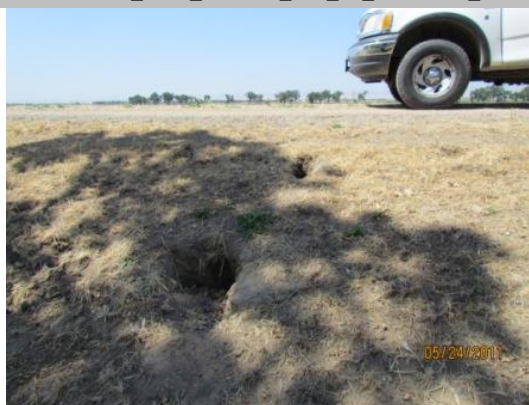
Photo 1 of 1 : SP_2015_RD1602_110_17_20150313_00006.jpg

Rodent hole was found on the waterside of the levee. The picture was taken from the crown looking upstream.

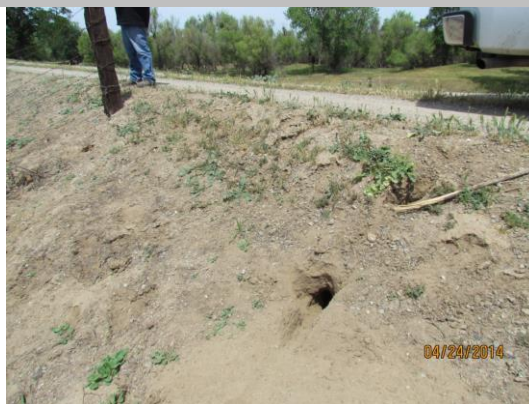
Photo 1 of 1 : SP_2015_RD1602_110_190_20150313_00062.jpg

A rodent hole was found on the waterside shoulder of the levee looking upstream.

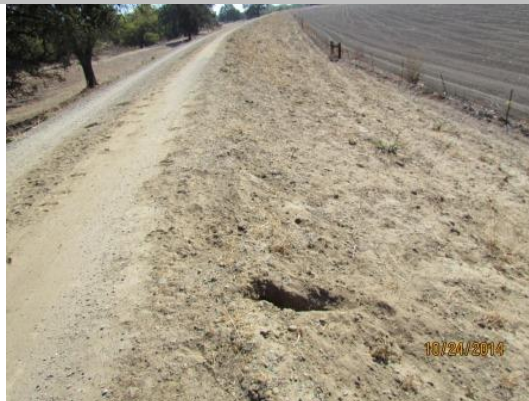
Photo 1 of 1 : SP_2015_RD1602_110_44_20150313_00021.jpg

A rodent hole was found on the landside shoulder of the levee looking upstream.

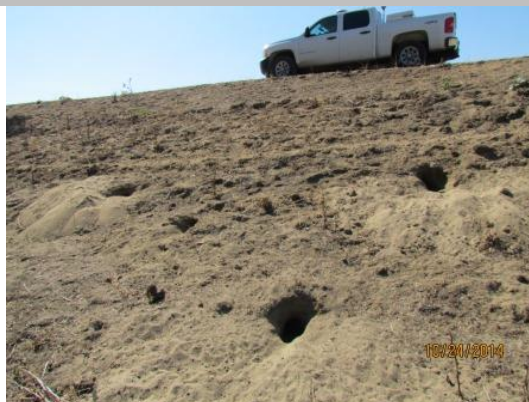
Photo 1 of 1 : SP_2015_RD1602_110_46_20150313_00023.jpg

View of the rodent holes on the waterside slope of the levee. The picture was taken from the toe of the levee during fall 2014 inspection.

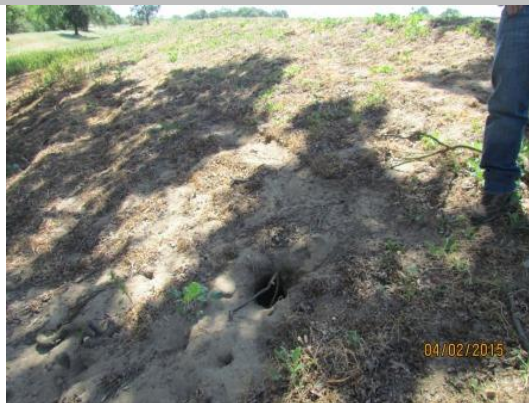
Photo 1 of 1 : SP_2015_RD1602_110_57_20150406_00087.jpg

Rodent holes were found on the waterside of the levee looking upstream.

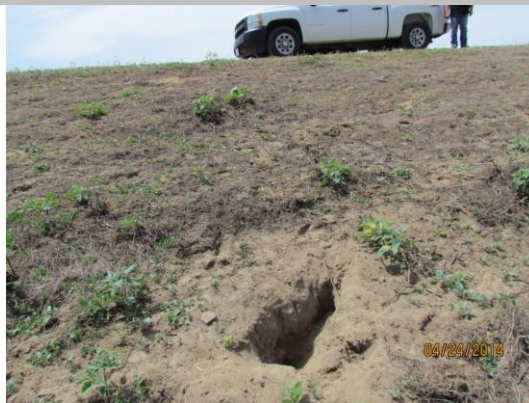
Photo 1 of 1 : SP_2015_RD1602_110_191_20150313_00063.jpg

A rodent hole was found on the waterside toe of the levee looking downstream.

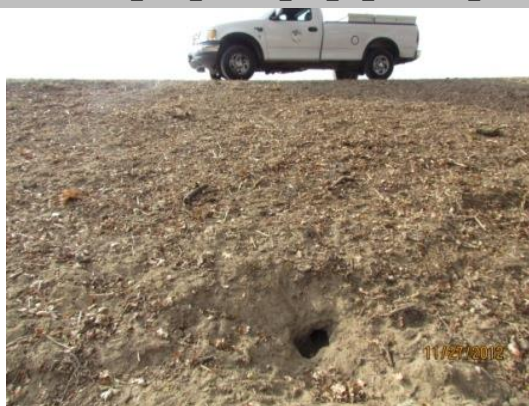
Photo 1 of 1 : SP_2015_RD1602_110_52_20150313_00026.jpg

A rodent hole was found on the waterside toe of the levee looking downstream.

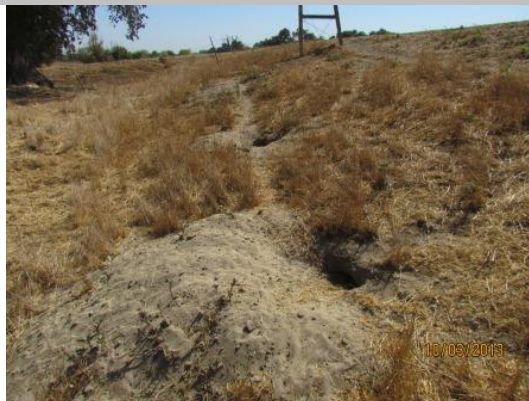
Photo 1 of 2 : SP_2015_RD1602_110_109_20150313_00060.jpg

Updated pictures of rodent holes were found on the waterside toe of the levee looking upstream.

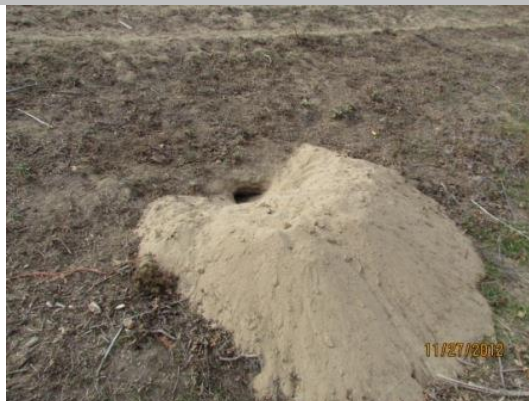
Photo 2 of 2 : SP_2015_RD1602_110_109_20150313_00061.jpg

A rodent hole was found on the waterside toe of the levee looking downstream.

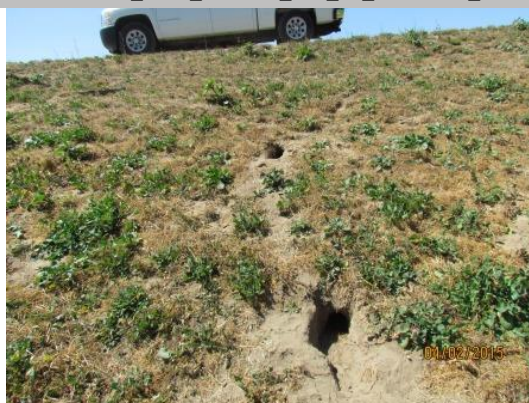
Photo 1 of 1 : SP_2015_RD1602_110_60_20150406_00088.jpg

Animal holes were found on the waterside slope of the levee looking upstream.

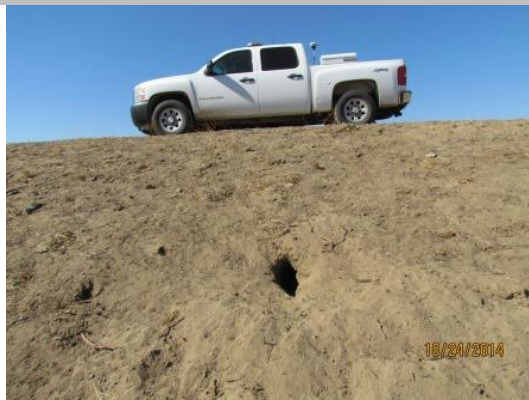
Photo 1 of 1 : SP_2015_RD1602_110_48_20150313_00024.jpg

View of a rodent hole on the waterside slope of the levee looking from the toe.

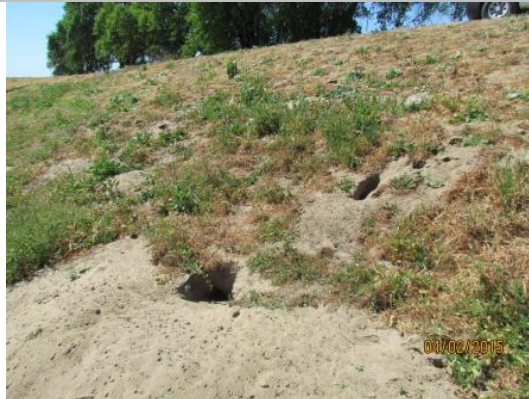
Photo 1 of 1 : SP_2015_RD1602_110_68_20150406_00089.jpg

A number of rodent holes were found on the waterside slope of the levee looking upstream.

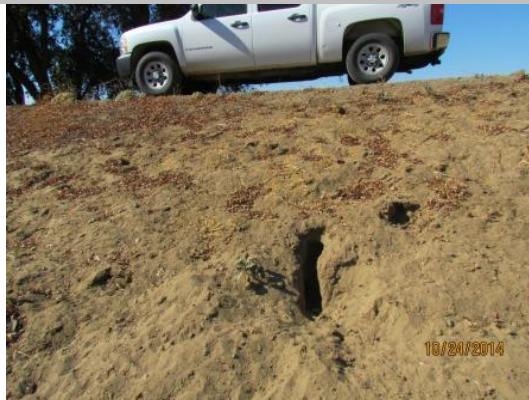
Photo 1 of 1 : SP_2015_RD1602_110_196_20150313_00064.jpg

Rodent holes were found on the waterside slope of the levee.

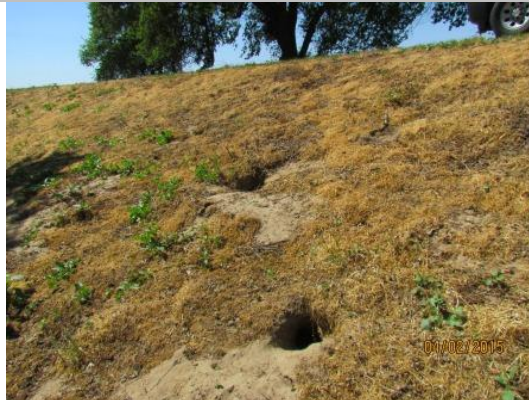
Photo 1 of 1 : SP_2015_RD1602_110_69_20150406_00090.jpg

Rodent holes were found on the waterside slope of the levee looking upstream.

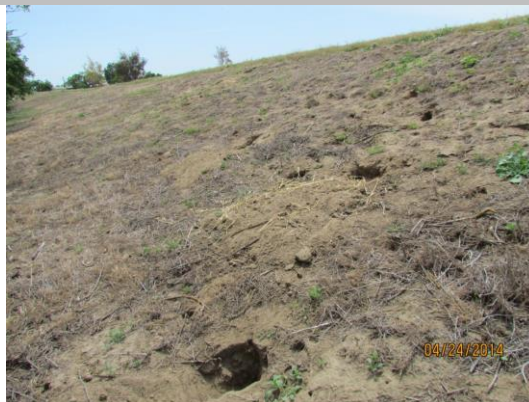
Photo 1 of 1 : SP_2015_RD1602_110_199_20150313_00065.jpg

Rodent holes were found on the waterside toe of the levee looking upstream.

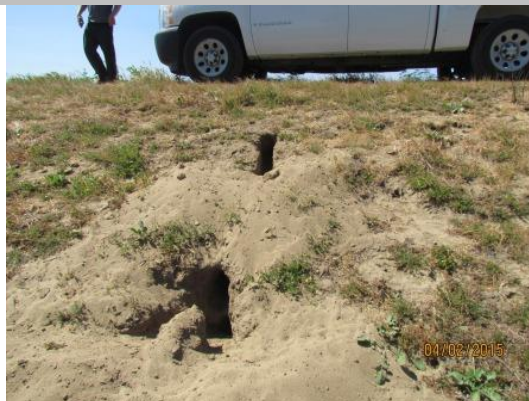
Photo 1 of 1 : SP_2015_RD1602_110_81_20150406_00091.jpg

A few animal holes were found on the waterside slope of the levee looking upstream.

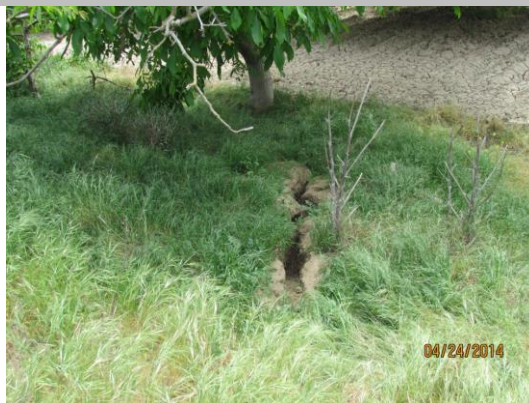
Photo 1 of 1 : SP_2015_RD1602_110_202_20150313_00066.jpg

LM Start	5.25	Rating **	M	Issue No.	202
LM End	5.25	Issue Type +	Ma	Location *	LS
Category	Earthen Levee			GPS Latitude/Longitude	
				Start	End
Item	Erosion / Bank Caving			37.436041 °	37.436041 °
				-121.035868 °	-121.035868 °
DWR ID	DWR_RD1602_01_s_2014_202				
Action/Comments					
Schedule repair of erosion site prior to the next inspection.

Erosion was found on the landside slope of the levee looking upstream.

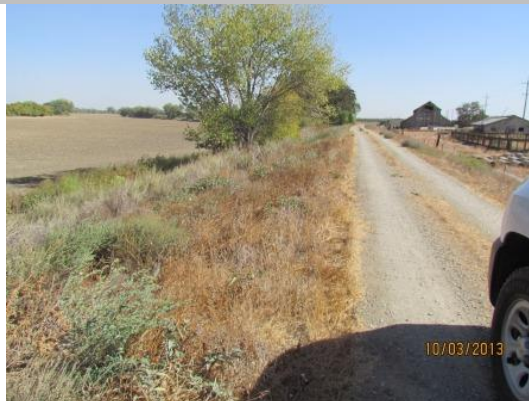
Photo 1 of 2 : SP_2015_RD1602_110_75_20150313_00046.jpg

Vegetation was found on the waterside slope of the levee looking upstream during fall 2013 inspection.

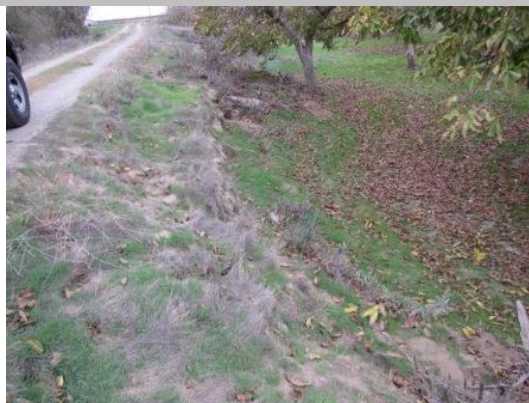
Photo 1 of 1 : SP_2015_RD1602_110_102_20150313_00057.jpg

LM Start	5.30	Rating **	M	Issue No.	102
LM End	5.30	Issue Type +	Ma	Location *	LS
Category	Earthen Levee			GPS Latitude/Longitude	
				Start	End
Item	Slope Stability			37.435533 °	37.435533 °
				-121.035371 °	-121.035371 °
DWR ID	DWR_RD1602_01_s _ 2012_102				
Action/Comments					
Repair slope instability.

View of significant damage and erosion to the landward slope looking upstream.

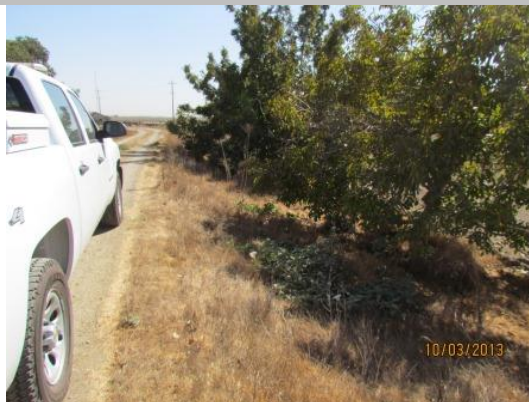
Photo 1 of 2 : SP_2015_RD1602_110_61_20150313_00032.jpg

Updated picture of vegetation on the landside of the levee. The picture was taken from the crown looking upstream during fall 2013 inspection.

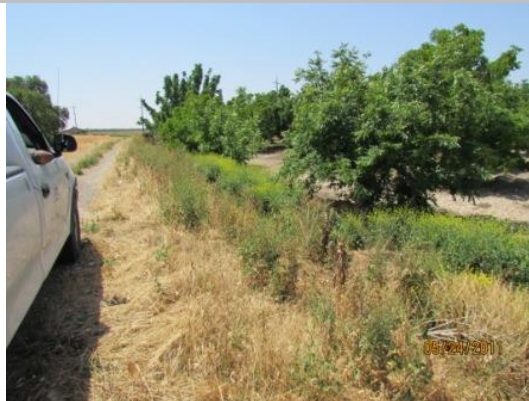
Photo 2 of 2 : SP_2015_RD1602_110_61_20150313_00033.jpg

Vegetation was obstructing the view of the landside of the levee. The picture was taken from the crown looking upstream.

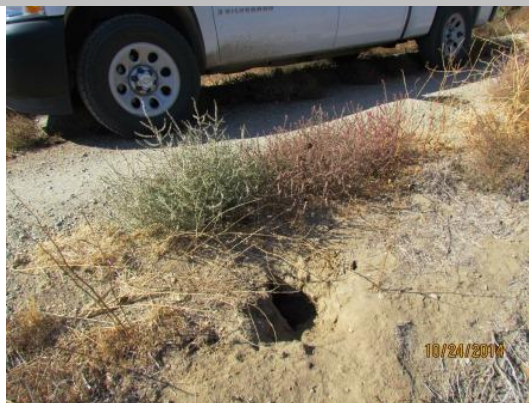
Photo 1 of 1 : SP_2015_RD1602_110_204_20150313_00067.jpg

An animal hole was found on the waterside shoulder of the levee looking downstream.

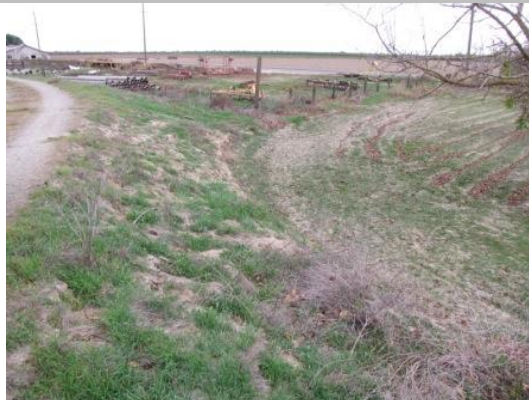
Photo 1 of 1 : SP_2015_RD1602_110_105_20150313_00058.jpg

LM Start	5.36	Rating **	M	Issue No.	105
LM End	5.36	Issue Type +	Ma	Location *	LS
Category	Earthen Levee			GPS Latitude/Longitude	
				Start	End
Item	Slope Stability			37.434699 °	37.434699 °
				-121.035063 °	-121.035063 °
DWR ID	DWR_RD1602_01_s _ 2012_105				
Action/Comments					
Repair slope instability.

View of tilling into the landward slope of the levee looking upstream. This slope has also been significantly damaged by rodent activity.
